FRACTOGRAPHIC INVESTIGATION OF SUBCRITICAL CRACK GROWTH AT INHERENT FLAWS IN POLYCRYSTALLINE CERAMICS

November, 1978

Prepared under Contract No. N00019-77-C-0328 for the Naval Air Systems Command, Department of the Navy

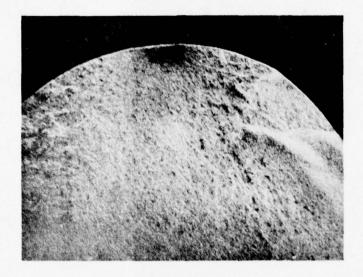
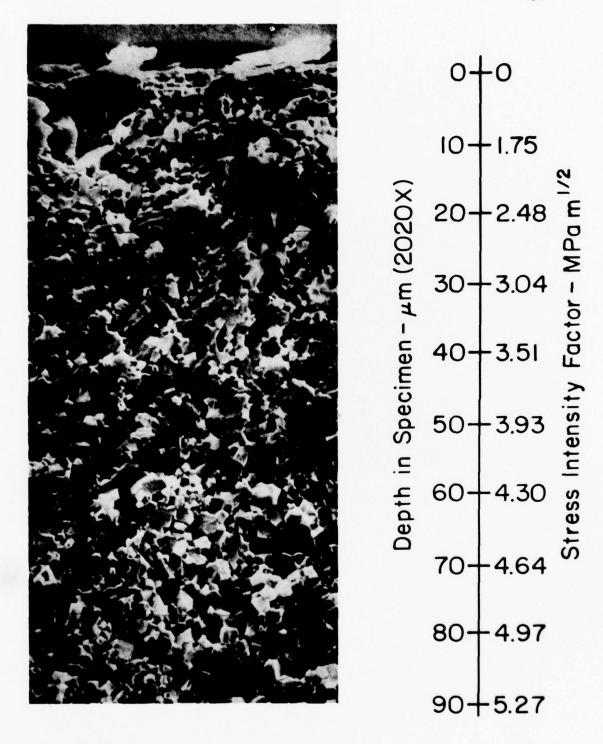
Fracture surface of a specimen fractured in flexure by a linearly increasing load at a fracture stress of 436 MPa is shown in Figures 1 and 2. The fracture origin is a machining flaw about 15-20 μm deep. This flaw is bounded by a region of mainly transgranular fracture that appears as a dark spot at the top of the fracture surface in Figure 1. At higher magnification in Figure 2, the increase in transgranular fracture along the radius from the fracture origin, followed by a decrease in transgranular fracture, is evident. The $K_{\bar{I}}$ vs. PIF curve for this specimen is given in Figure 3. A horizontal dashed line indicates $K_{\bar{I}C}$ for the polycrystalline material. The minimum in PIF (maximum in percent transgranular fracture) almost coincides with $K_{\bar{I}C}$.

Figure 1 Hot Pressed Alumina (Specimen R-5) Fractured by a Linearly Increasing Load at 436 MPa (30 X).

Figure 2 Hot Pressed Alumina (Specimen R-5) Fractured by a Linearly Increasing Load at 436 MPa (2020 X).

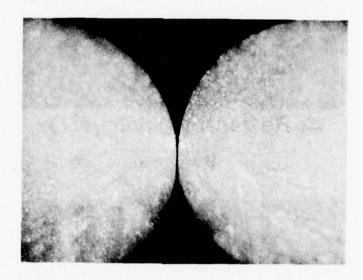
Figure I Comparison of reflecting spots in both halves of a 96% alumina specimen (Specimen AR-2, fractured in flexure at room temperature at 434 MPa).

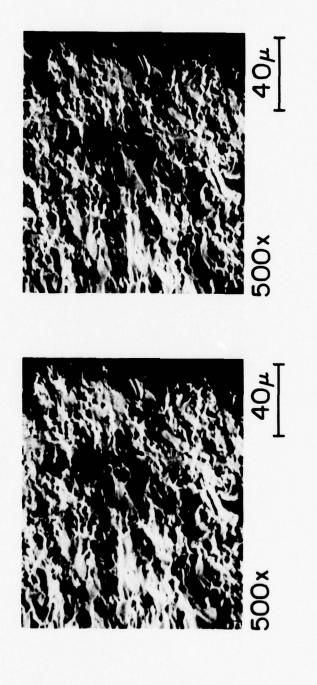
Stereo SEM was used to examine fracture surfaces surrounding pores. An example, specimen N-37 fractured in flexure at -196°C, is shown in Figure 4. The fracture originated at the large pore near the center of the photo as indicated clearly by lines radiating from the pore. The pore is surrounded by a region of transgranular fracture. The straight edges under the pore indicate that at least part of the pore was bounded by a large grain but it is clear that the area of transgranular fracture spreads into other grains. It has been argued that the fracture stresses at pores can be calculated by assuming that the pore is surrounded by a crack one average grain size in depth. These arguments have been reviewed in detail by Rice $^{(4)}$. In the present case one can estimate the critical flaw size assuming a penny-shaped crack, using Equation (1). The resulting flaw radius is $43~\mu m$. This radius is clearly much larger than the radius of the pore plus one average grain size and it is also larger than the distance from the center of the pore to the straight boundary below the pore. Therefore, it is clear that in the present case, no simple rule

Fracture origin at a pore in 96% alumina stereopair, (specimen N-37 fractured at -196°C, 500 x). Figure 4

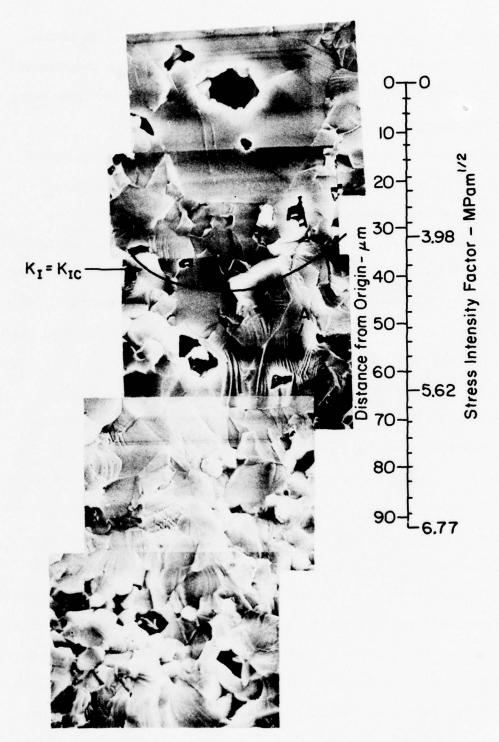
The region near the pore is a region of 100% transgranular fracture. Apparently, the crack grew around the pore on slightly different planes forming the tail extending from the left side of the pore. As the distance from the pore increased there is increasing evidence of intergranular fracture and pullouts. The boundary at which K_I equals the estimated K_{IC} passes through some grains fractured intergranularly. Beyond this boundary there is increasing evidence of disruption of the fracture surface caused by higher values of K_I , including cleavage steps and other fracture markings. One of the most interesting of these markings is indicated by the letter A. The suggestion has been made that these are so-called cathedral dome markings that are observed bounding fracture mirrors in fractures of sapphire single crystals. The markings at A can be compared with those observed in sapphire and attributed to rhombohedral cleavage by Abdel-Latif, Tressler and Bradt (18). If this identification is correct,

Figure 8 Composite photograph of the fracture surface along a radius from the fracture origin in 96 % alumina (Specimen N-37, fractured at -196 °C).

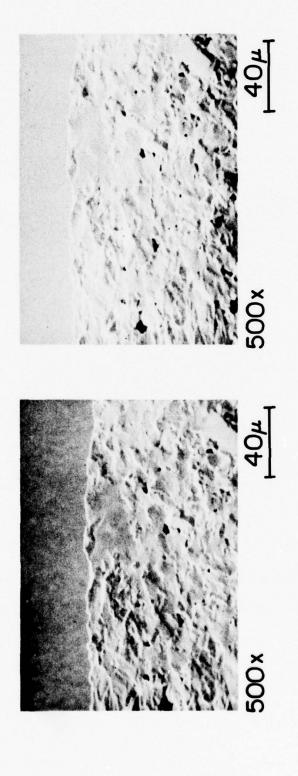
Figure 10 Fracture surface of a 96% alumina specimen fractured at room temperature stereopair,(Specimen R-8, fracture stress 457 MPa) mag.

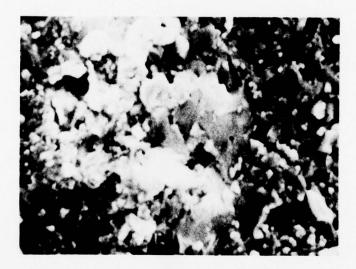
A. Fracture surface (70X)

B. Fracture origin (7000X)

Figure I Fracture surface and internal fracture origin, specimen 2T

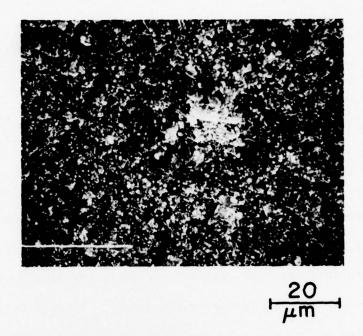
Figure 2 Dark region surrounding fracture origin, specimen 4T (1000X)

Figure 3 Transgranular fracture at fracture origin, specimen IT (1500X)

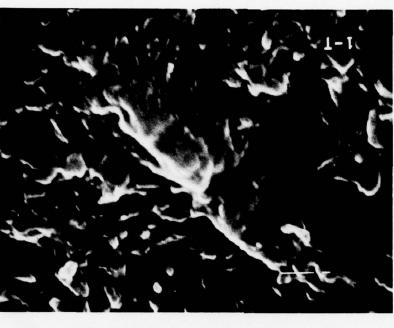
Figure 5 Hummock surrounded by depressions, specimen IT, stereo pair (10,000X)
